Seaman Corporation

Improved Polyurethane Storage Tank Performance

Contract No. SP0600-04-D-5442, Delivery Order 1029

FY2009 Final Technical Report

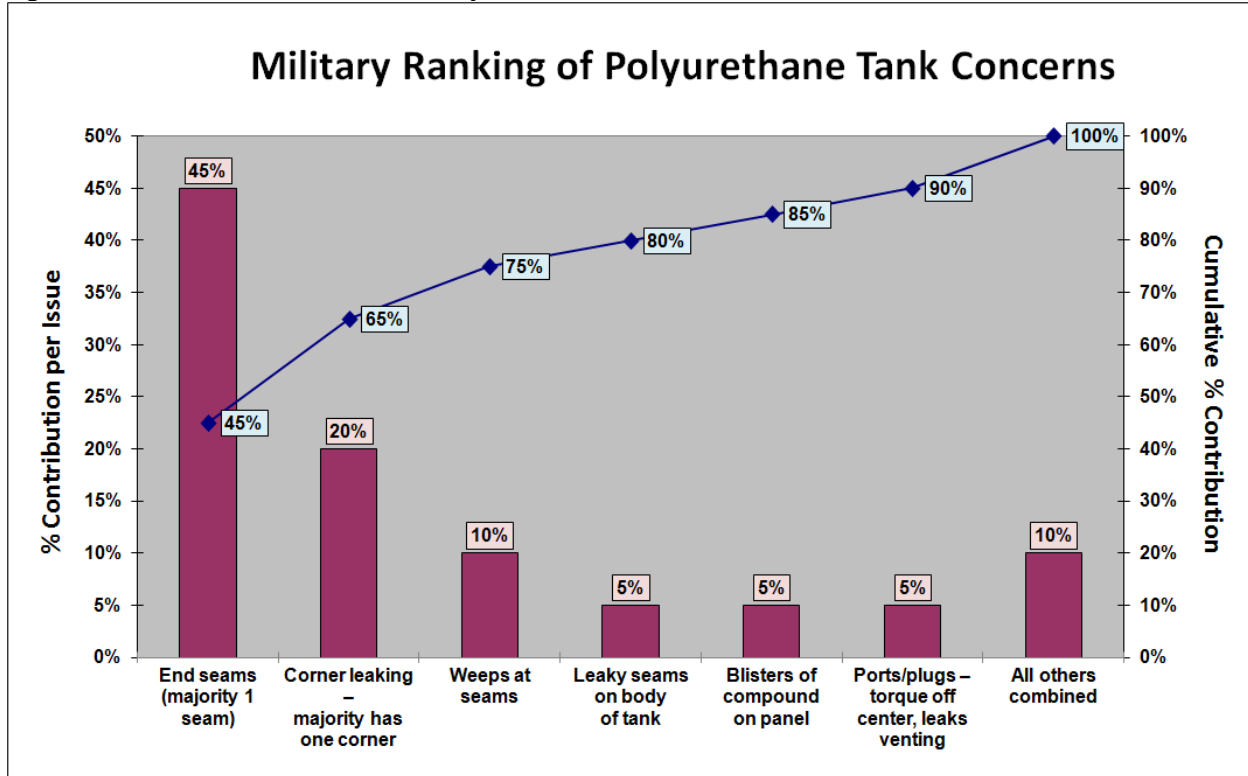
Figure 3.1.1 – Pareto of Roundtable Polyurethane Tank Concerns

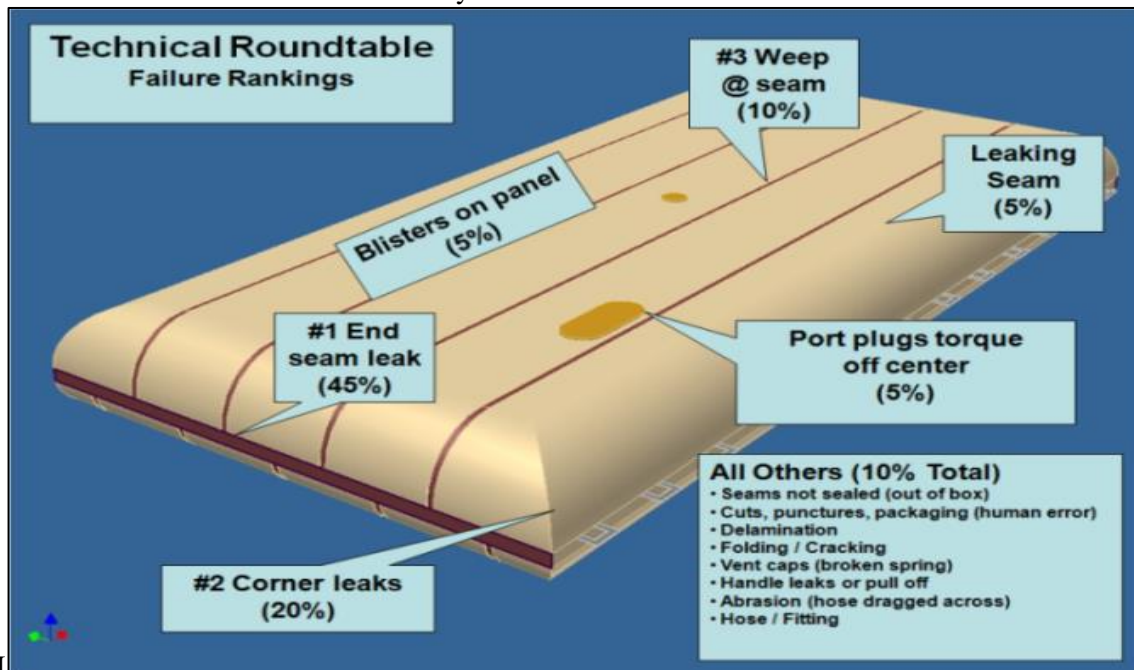
Figure 3.1.2 further classifies the data captured in the Pareto chart and identifies contributing factors relative to their typical location on the CFT. In addition, it lists the remaining items (all individually less than 2%) which make up the “All Others” category.

Figure 3.1.2 – Schematic of Roundtable Polyurethane Tank Concerns

These issues were discussed at length at the beginning of the Failure Analysis working sessions and served as the foundation for much of the inputs into the Fault Tree and Failure Modes Effects Analysis.

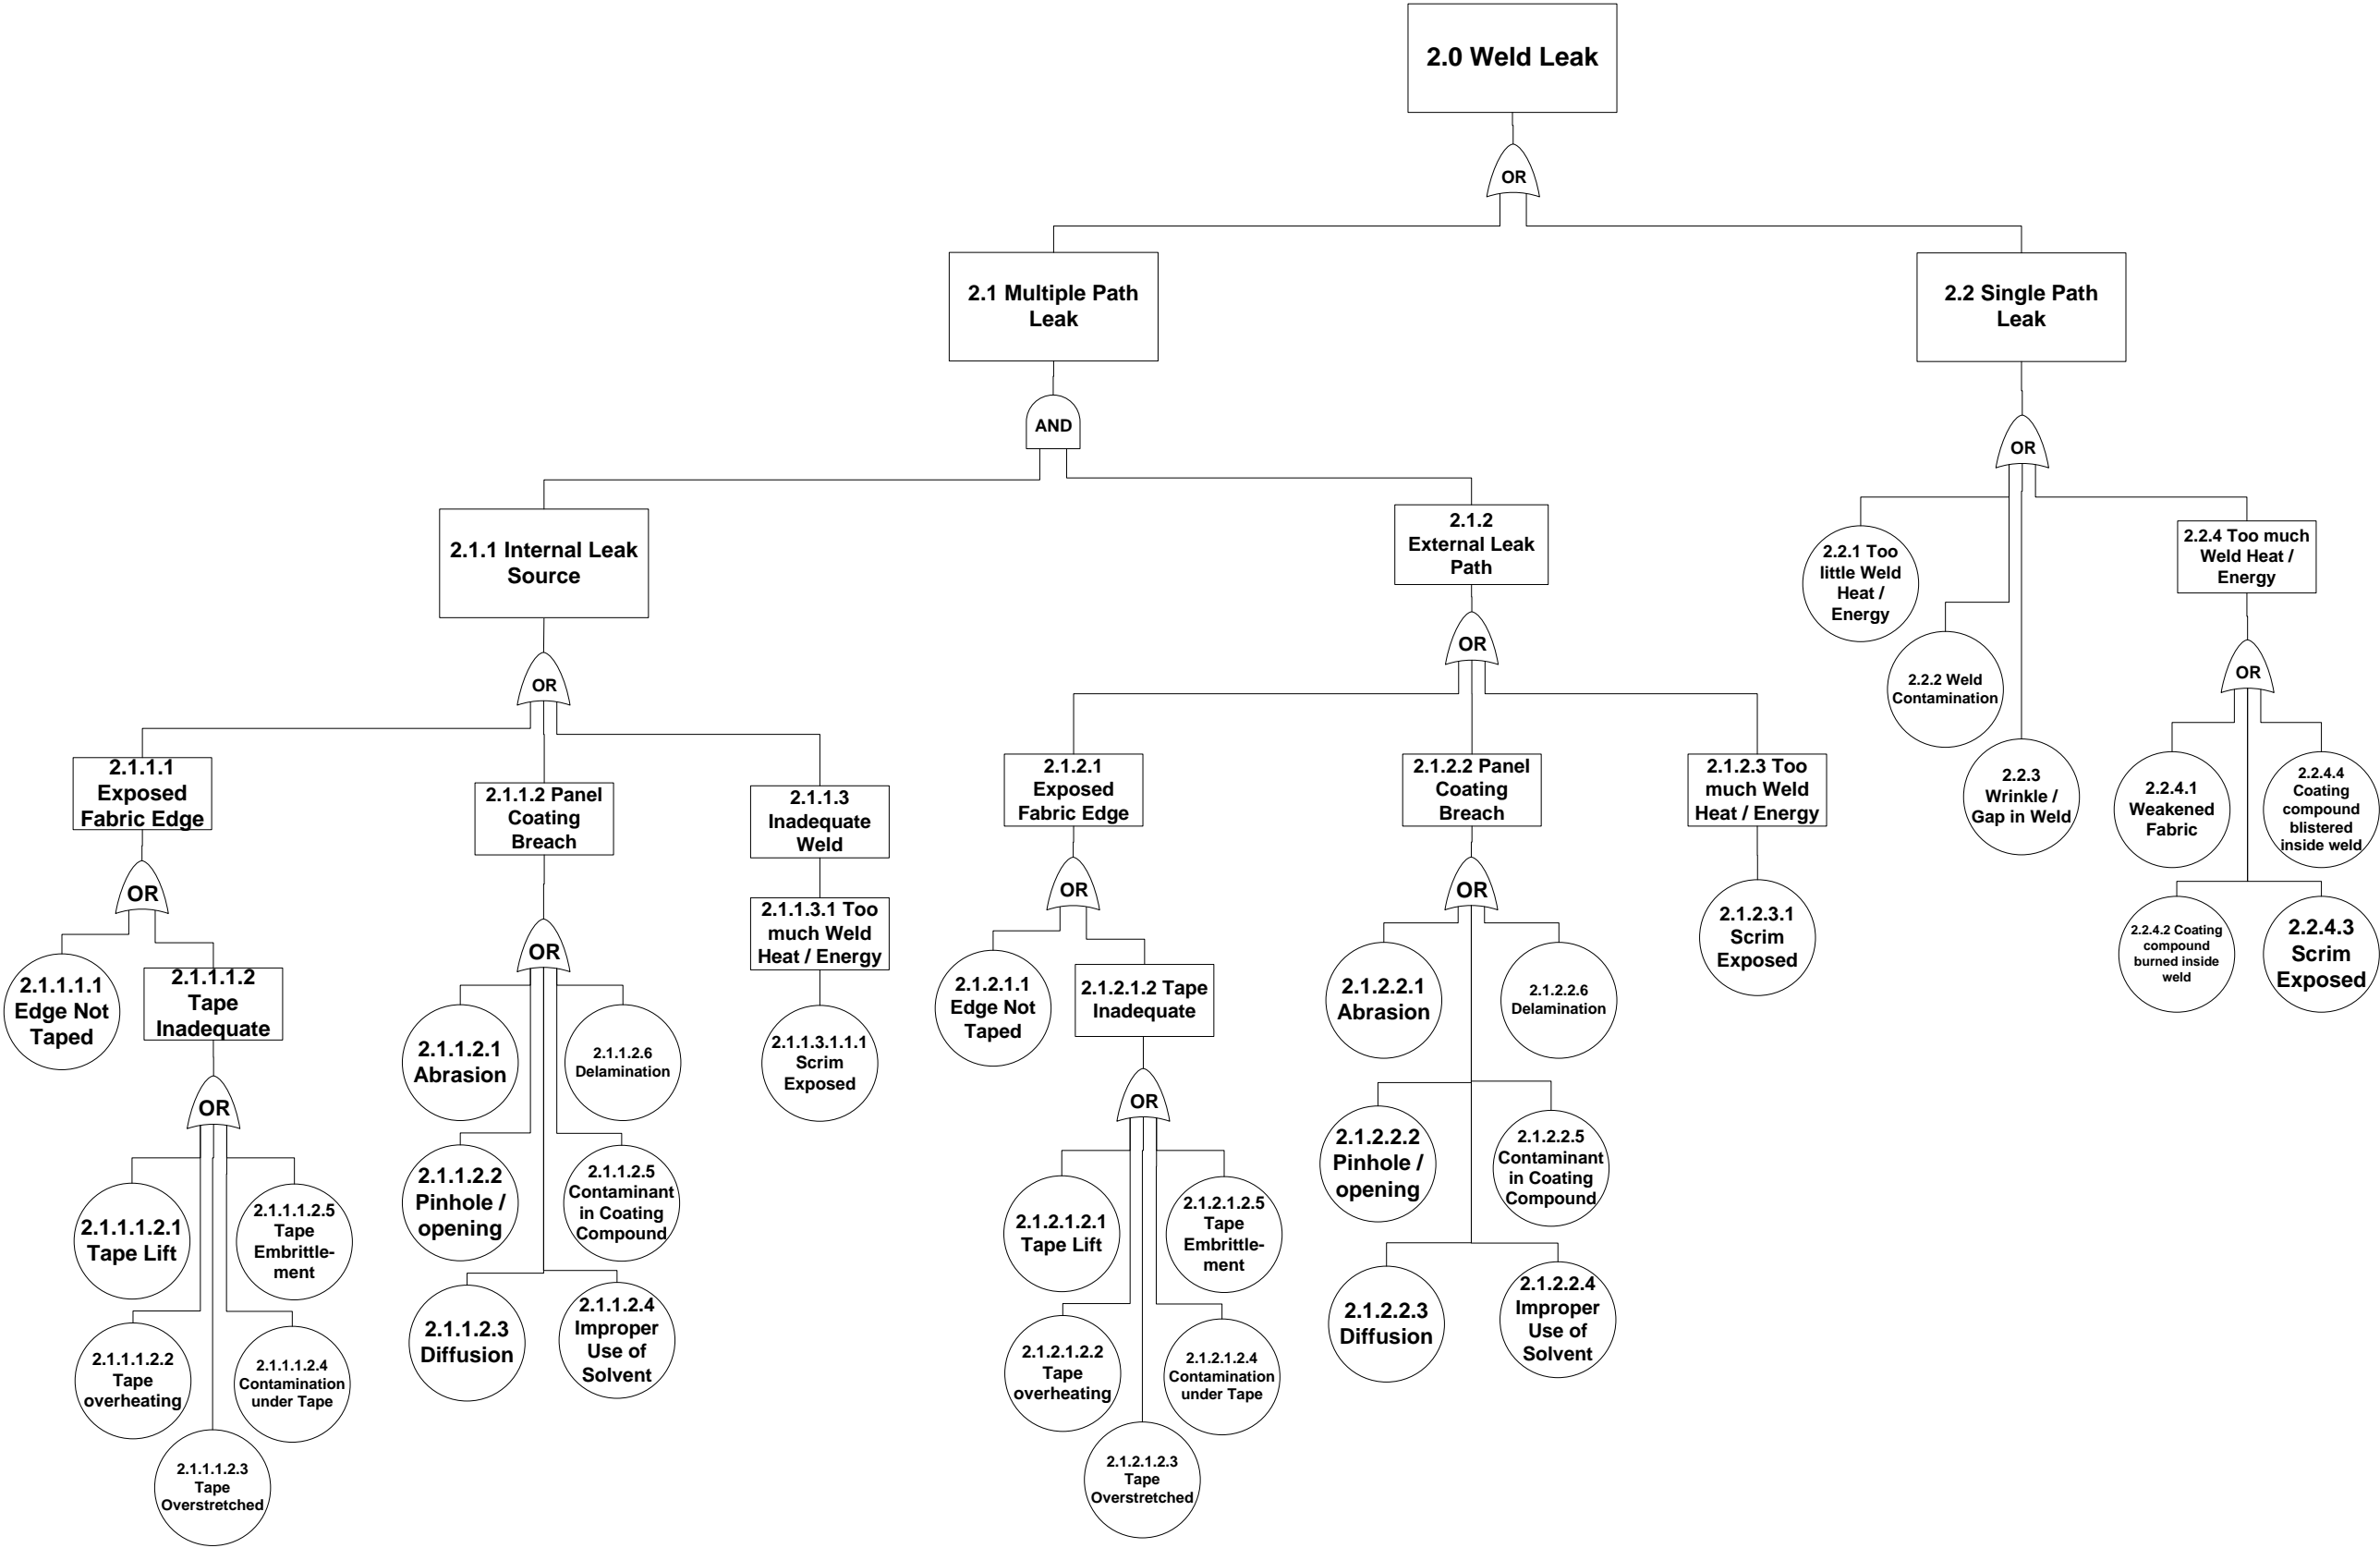
Figure 3.2.1 – Fault Tree Analysis (FTA) Weld Leak Example

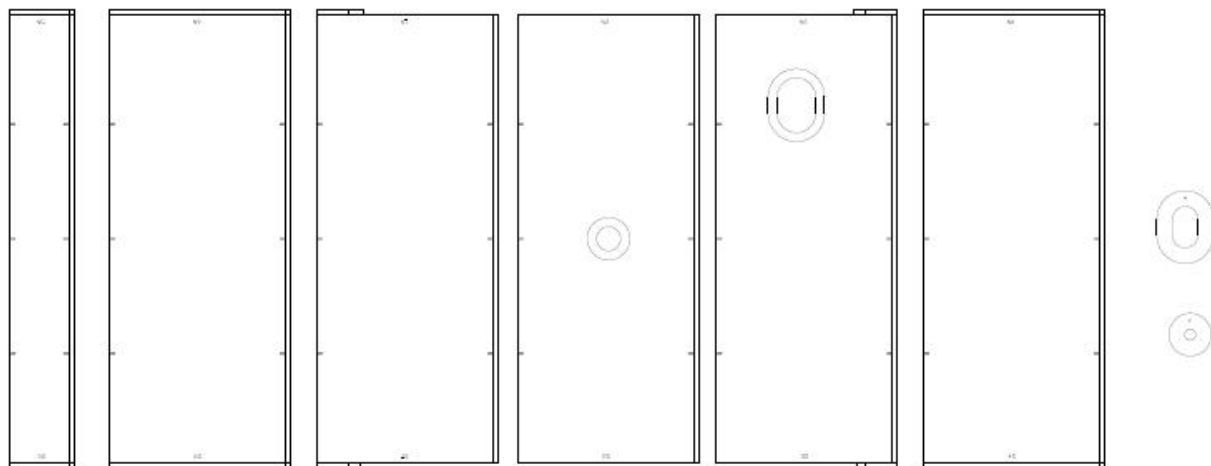
Figure 4.2.1 – Typical Standard Design Tank showing elevated corners and ends

As the tank fills, the center of the tank rises quicker than at the edges due to the way the tank is fabricated and the constraints imposed by its welded geometry. This causes the peripheral edges of the tank to lift into the air, creating the characteristic standard design tank profile. This is clearly evident in the pictures from the test site (Figure 4.4.16).

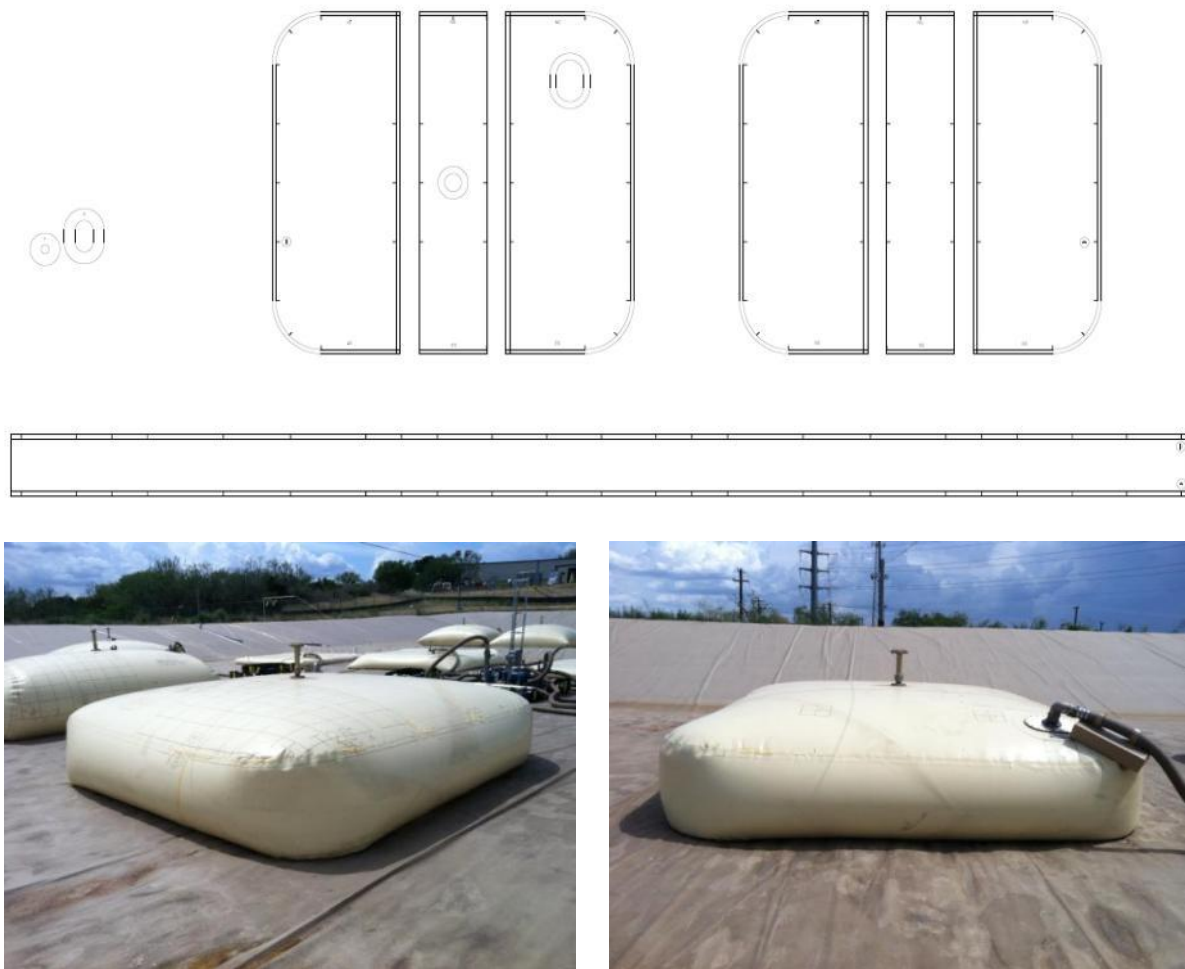
Figure 4.4.18 – Belly Band Design, Corner and End Fill Photographs

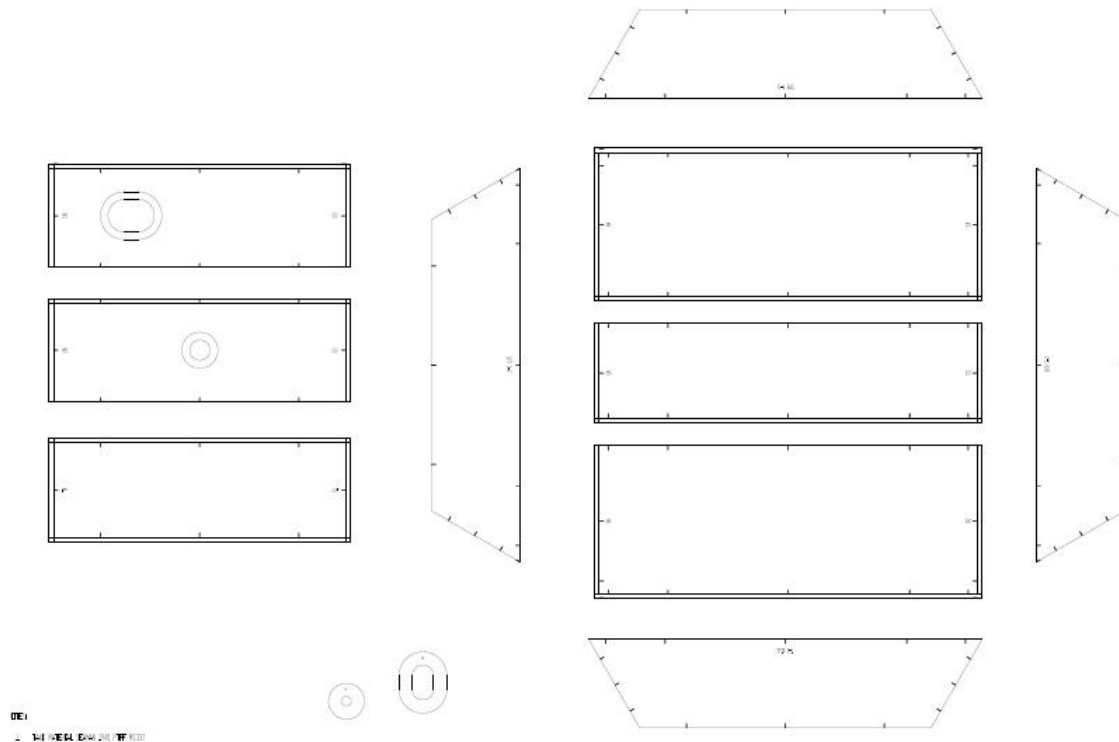
Figure 4.4.19 – 10 Panel Trapezoid Design, Corner and End Fill Photographs

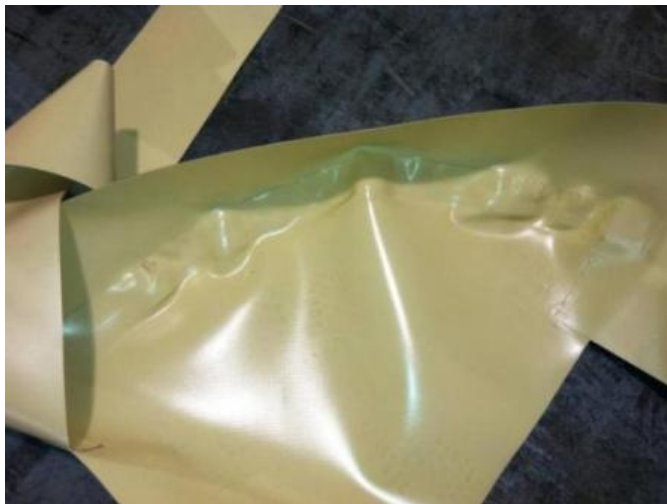
Figure 4.5.3 – Belly Band 24-inch Corner Radius “Pucker”

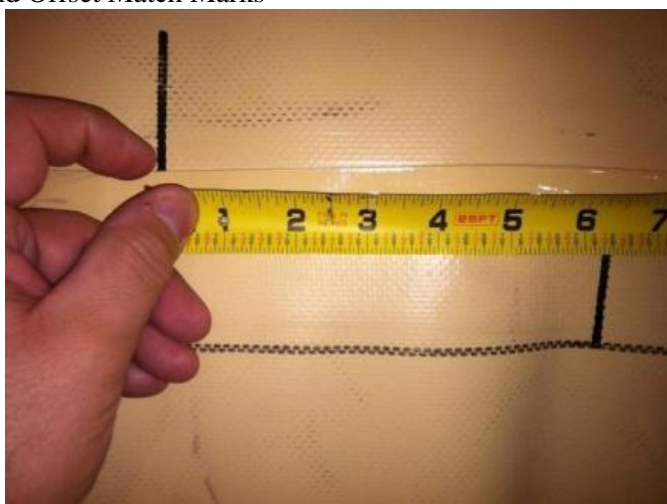
If the feed rates vary between the belly band weld to the top versus the bottom blanket, a counter twist between tank top and bottom could be introduced which may potentially cause the tank to be unstable when filled with fluid. The fabricator who welded this tank has experience with a similar design of their own and cannot see it being done practically in any size larger than 3,000 gallons. The twist is much more predominant if the top and bottom are started in opposite directions. When the tank is flipped over and set-up for the easiest feed through the welder it aligns the material in the opposite direction from the initial weld. The picture below illustrates that even though the initial match marks were aligned, by the time the band came to a close the match marks were off by > 6 inches (Figure 4.5.6). It appears that this difference increases when the fill direction on the belly band panel opposes the warp direction on the top and / or bottom blankets.

Figure 4.5.6 – Belly Band Offset Match Marks

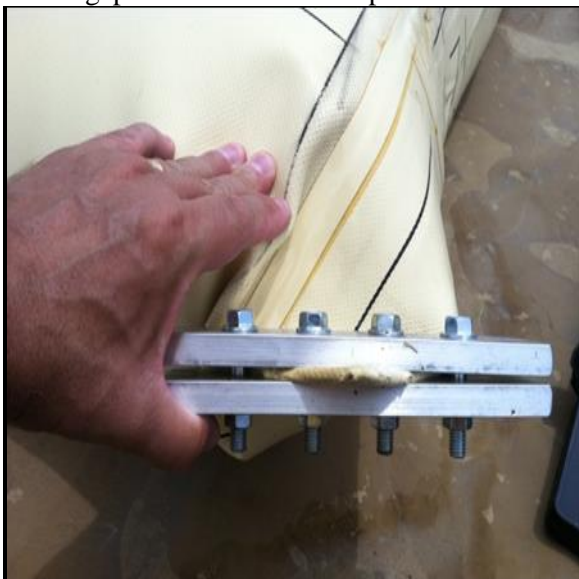
Figure 4.5.16 – Clamp Plates Cantilevered – narrower gap on outside between plates

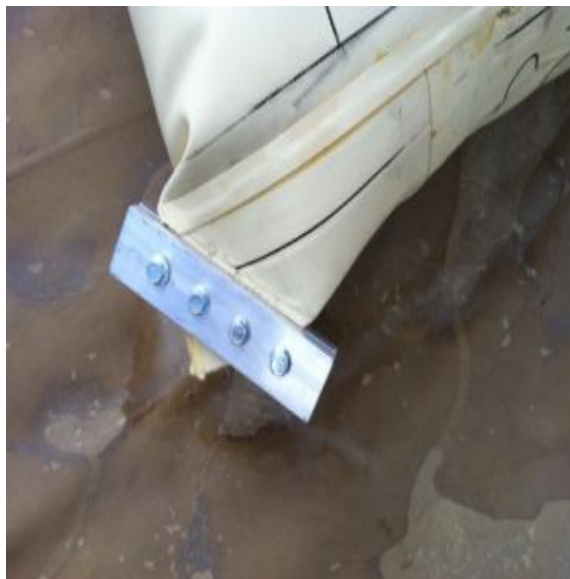
Figure 4.5.17 – Associated Corner Leak

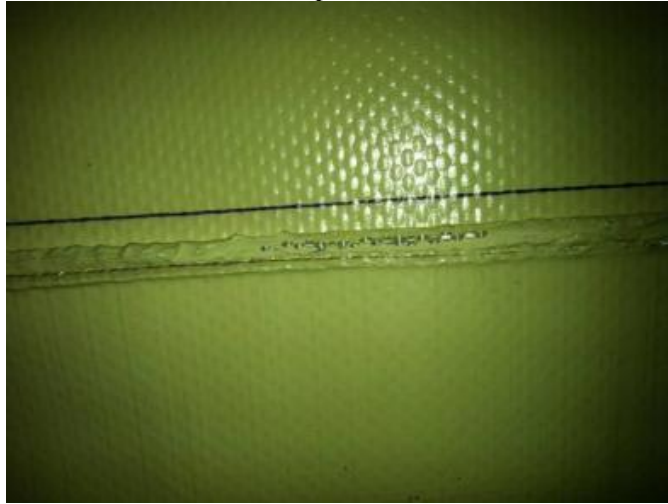
A few additional issues were captured during the RF welding process. If welding multiple plies does not appear to create an integral weld at the appropriate power setting, increasing the platen pressure or weld power should be the first options tried. In some instances, a closing seam weld was hit multiple times to get an integral weld. However, too much compound flow may occur leaving either a damaged fiber bundle at the seam or exposed scrim (Figure 4.5.18).

Figure 4.5.18 – Exposed Fiber Bundle Due to Compound Overflow

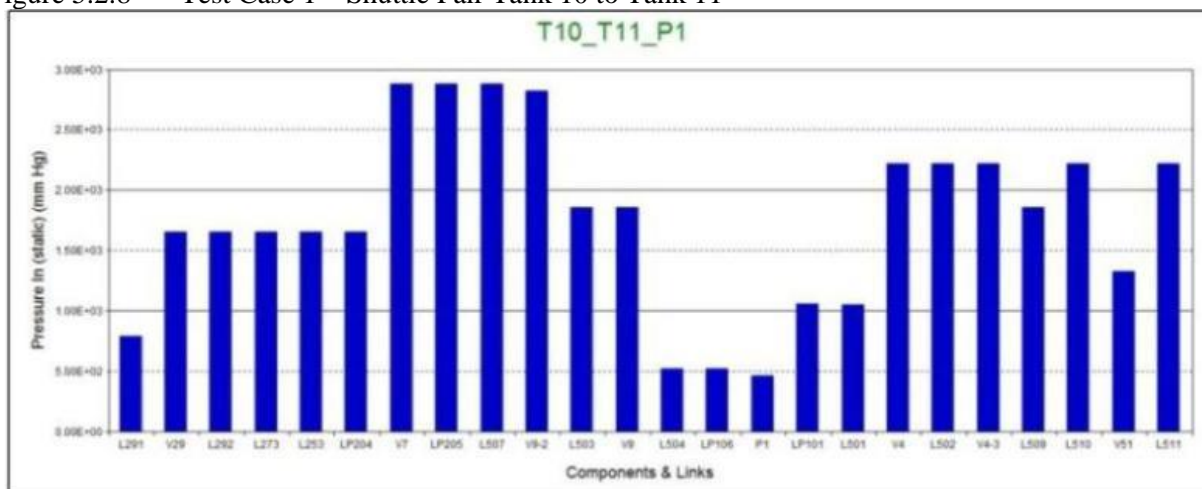
Figure 5.2.8 Test Case 1 – Shuttle Pair Tank 10 to Tank 11

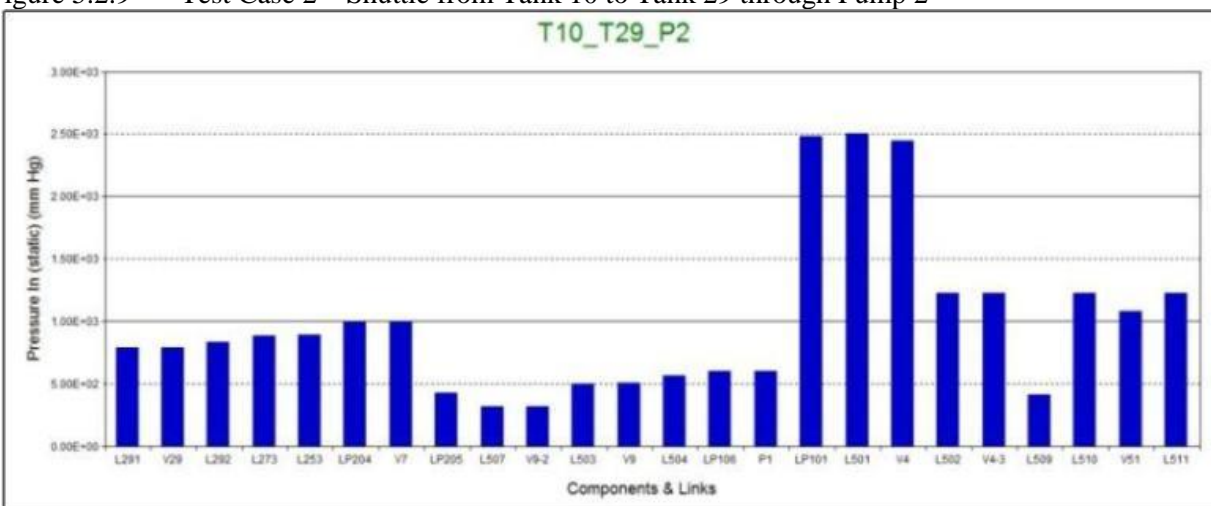
The last two cases were chosen as worst-case scenarios. The second case represents having to shuttle from Tank 10 (in the top bay, upper left corner) to Tank 29 (in the bottom bay, farthest right location). The assumption was that Pump 1 would not be available for use (i.e., theoretically down for repair). The results for this example are shown in Figure 5.2.9.

Figure 5.2.9 Test Case 2 – Shuttle from Tank 10 to Tank 29 through Pump 2

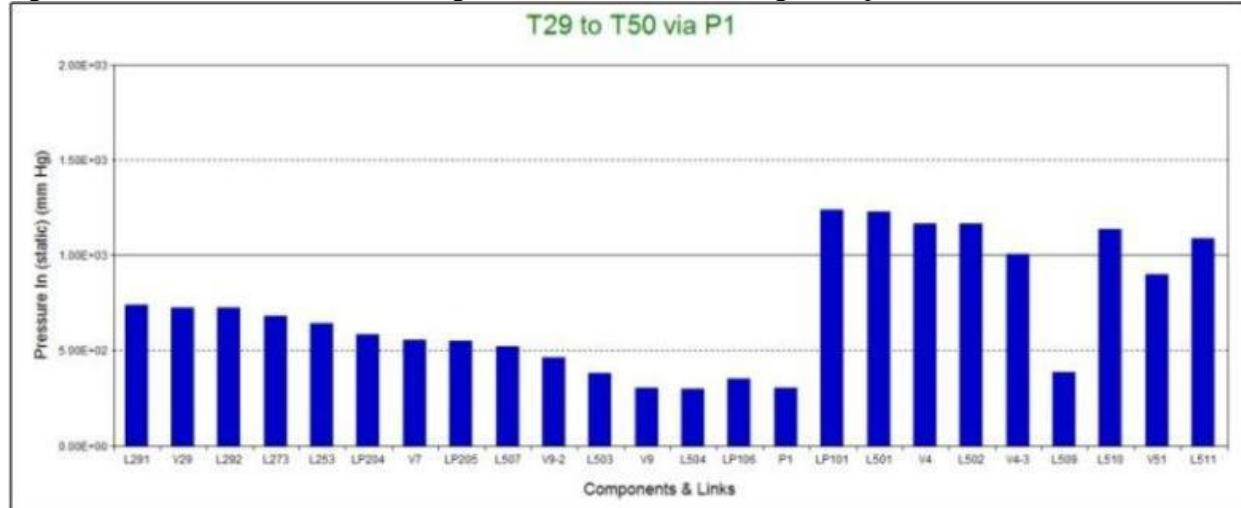
The final model looked at shuttling from Tank 29 back to the T50 reserve tank through P1. Once again, the assumption was that P2 (Pump 2) was not available for use and the fuel needed to be off loaded to the reserve tank. The graph of this situation is shown in Figure 5.2.10.

Figure 5.2.10 Test Case 3 – Draining Tank 29 to Tank 50 through Pump 1

For all three cases, the pressure monitoring throughout the network indicated that, even though the models simulated were worst case, the minimum equilibrium (or saturated) vapor pressure for the onset of cavitation was not reached. All cases were run at an external temperature of 110 °F to ensure that they reflected “worst case” based on environmental conditions.

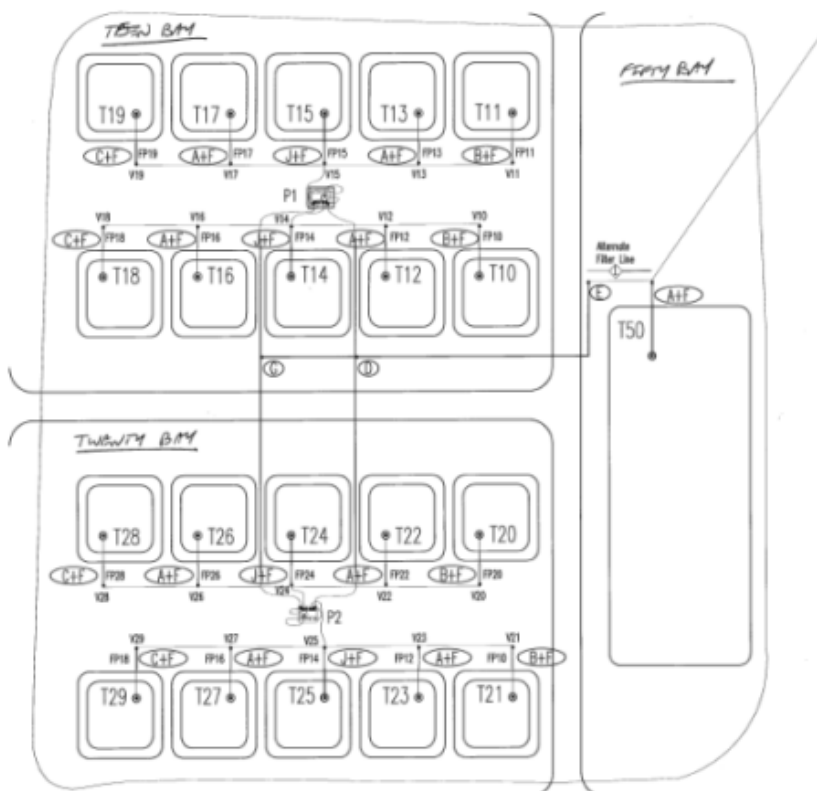
Figure 5.2.11 Tank Pair Location Schematic

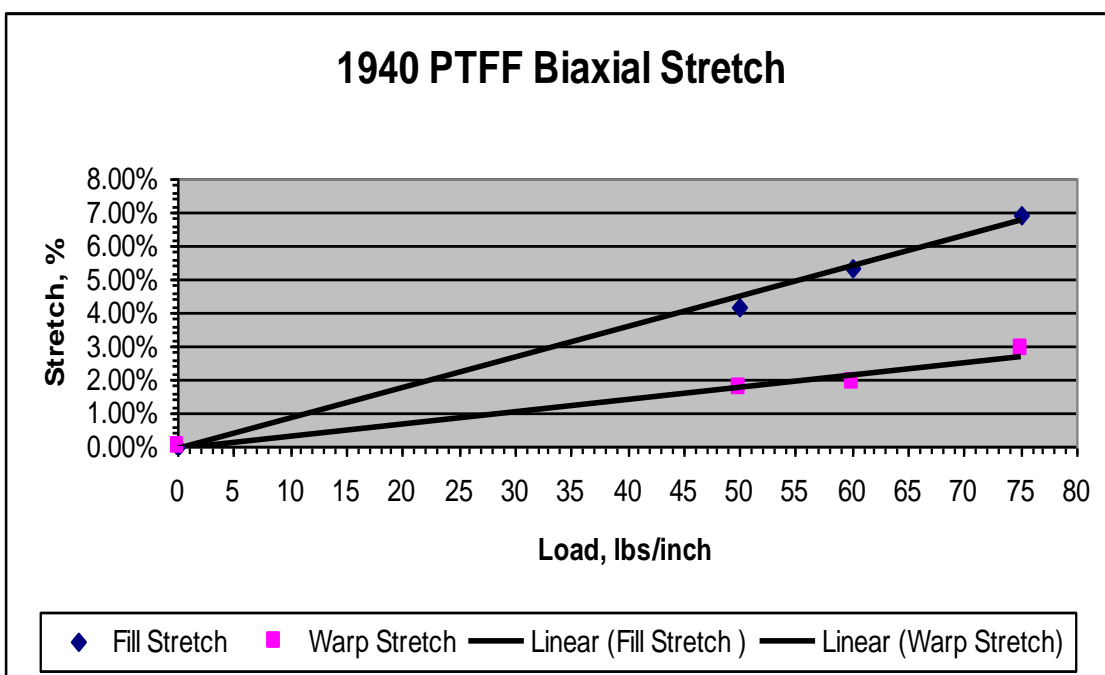
Figure 5.3.2 1940 PTFE Material Biaxial Stretch Curve

Per this graph, for the 1940 PTFE at a load of 55 lbs_f/in, the associated stretch would be ~2% for the warp and ~5% for the fill. It is important to note that during the FY2008 Model Tank testing, multiple stretch panel locations were measured on the tank. The peak value for all of the panel measurements was chosen as representative for both warp and fill stretch for the each fill volume measured, since this would correlate directly to the maximum value of welded seam load that would be recommended.

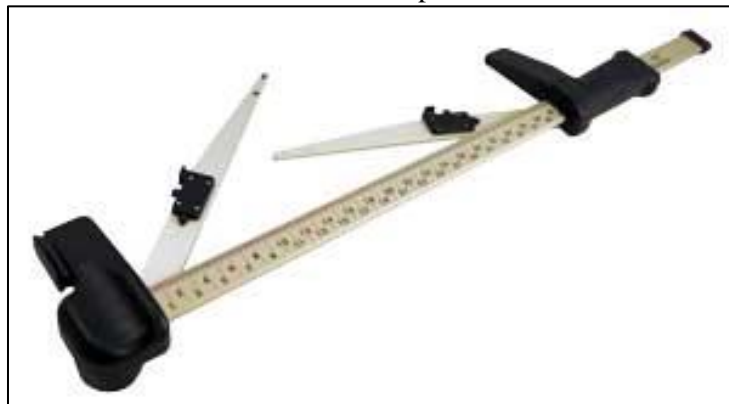
Figure 5.3.14 Haglof Mantax Black / Green Laser Calipers

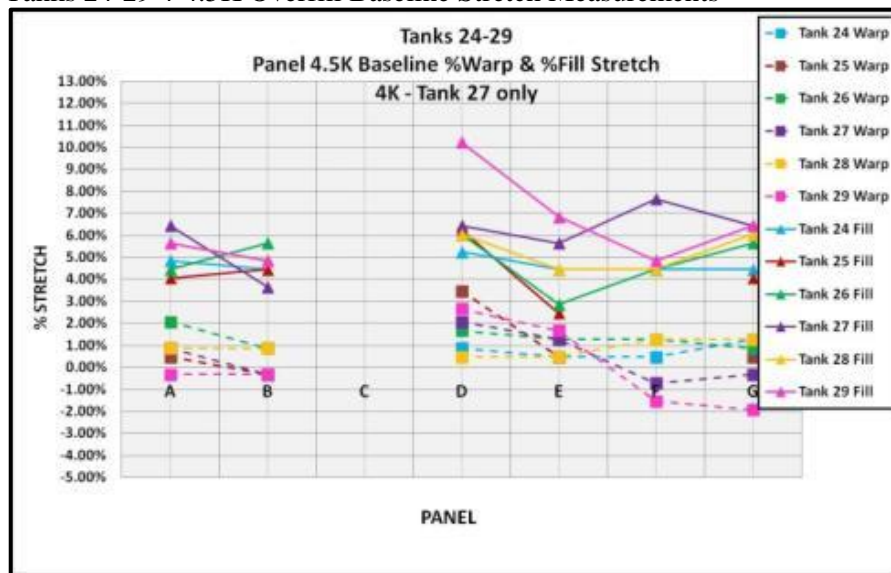
Figure 5.4.30 – Tanks 24-29 4-4.5K Overfill Baseline Stretch Measurements

The initial baseline overfill stretch measurements of most of the tanks met minimum requirements $>7.7\%$ fill and $>1.7\%$ stretch. The major exceptions occurred in the prototype designs (Tank 24-29). These tanks were at or near maximum overfill until fuel exited the vent resulting in an undesirable outcome. The testing had just initiated and it was decided to maintain the established fill level maximums in light of increasing summer temperatures. The tank fill stretch maximum in an overfill condition exceeded the 3K fill stretch by 50% - 250%, dependent greatly on tank design.

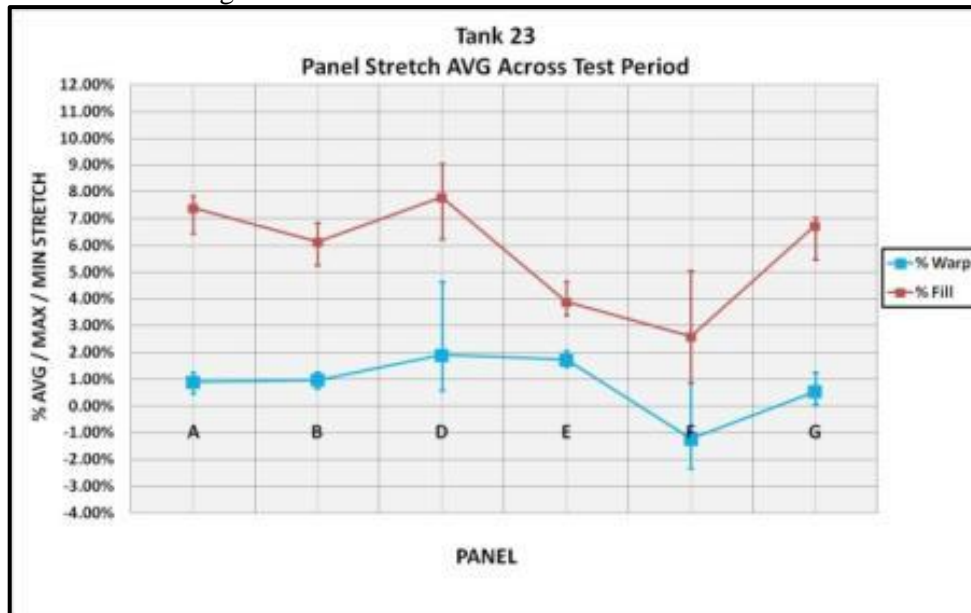
Figure 5.4.51 – Tank 23 Average Panel Stretch across Test Period

The prototype tanks showed consistently lower stretch at overfill. The worst case stretch location “D” did experience measurements that exceeded the >7.7% fill and >1.7% warp requirement represented by the standard deviation error bars. However, on average, these values were slightly lower than the target. Paired with the lower zero baseline stretch numbers seen in Figure 5.4.31, overall the prototype tank designs stretched less. These tanks were designed based on a 3,000-gallon three dimensional volume in which the tank material would have little or no significant stretch. The material in a standard pillow tank, by comparison, begins stretching at 50 – 67% of the total fill volume. Adding in the additional material and lower tank height per volume these designs require, the results are as expected.

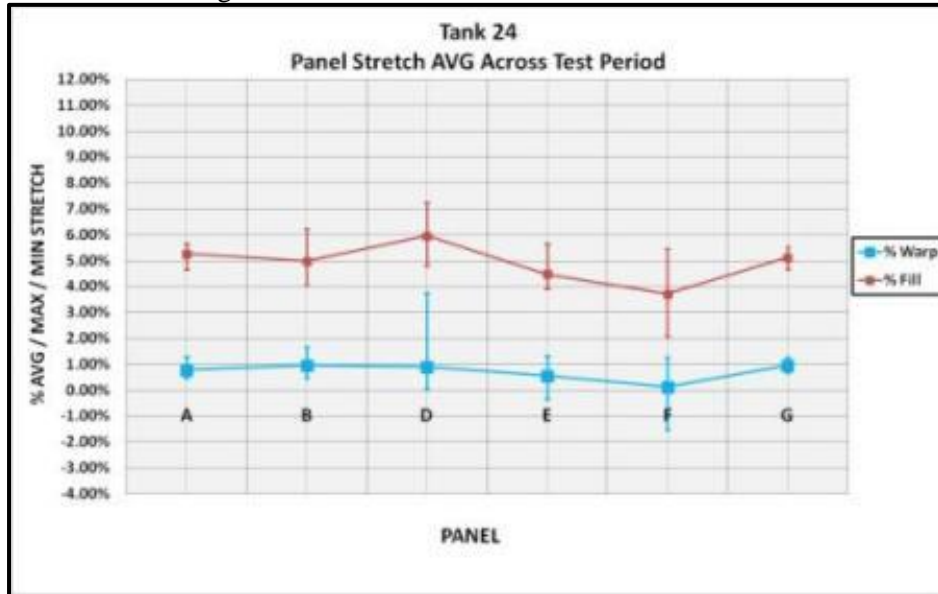
Figure 5.4.52 – Tank 24 Average Panel Stretch across Test Period

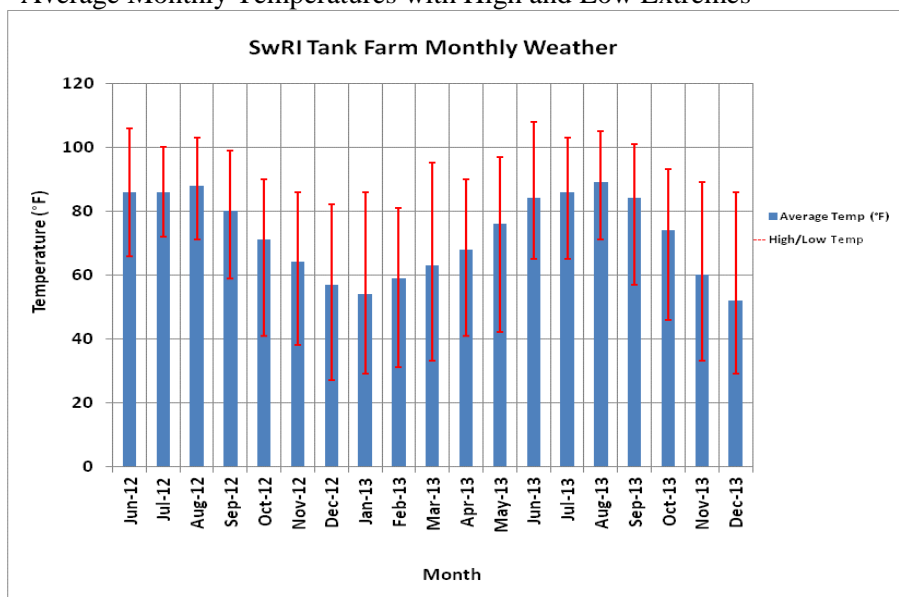
Figure 5.4.58 – Average Monthly Temperatures with High and Low Extremes

It was noted during testing that temperature did seem to have some impact on leak propagation, severity and rate. This is discussed in detail in the Leaks section (5.4.6).

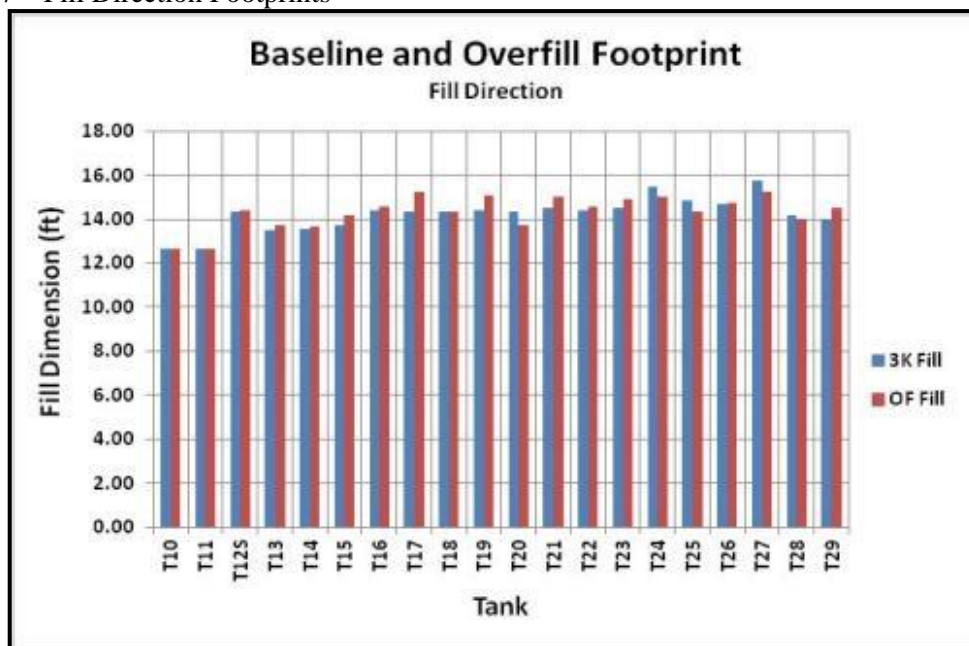
Figure 5.4.67 – Fill Direction Footprints

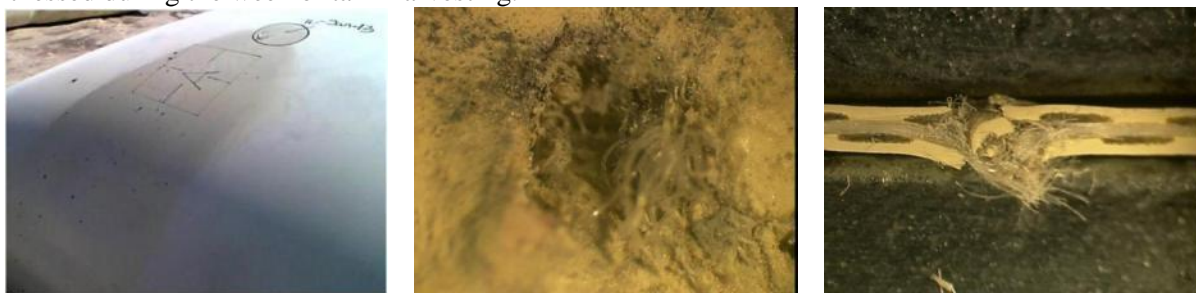
Figure 5.4.72 – Class II – T11-1 – Closing Seam – 23 JUL 12

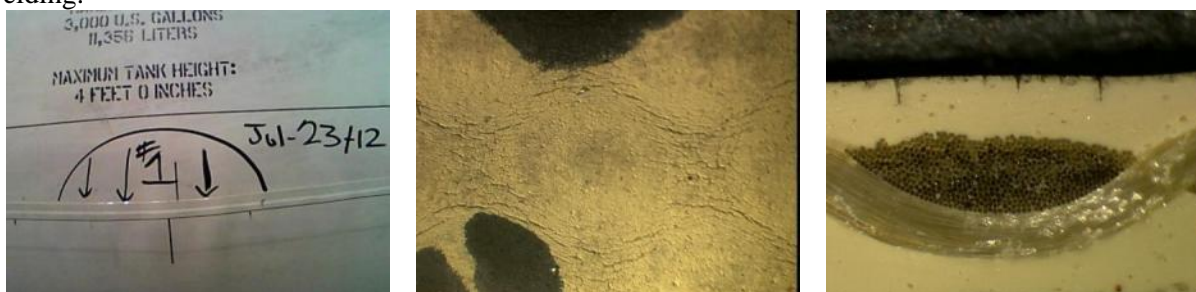
Figure 5.4.73 – Class II – T11-2 – T-Closing Seam – 10 AUG 12

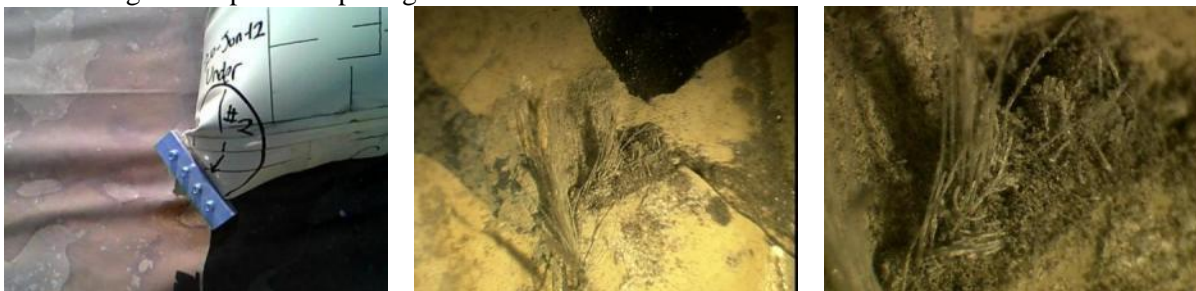
Figure 5.4.81 – Class II – T24-4 – T-Seam Closing – 27 NOV 12
Adhesive applied to base material degradation

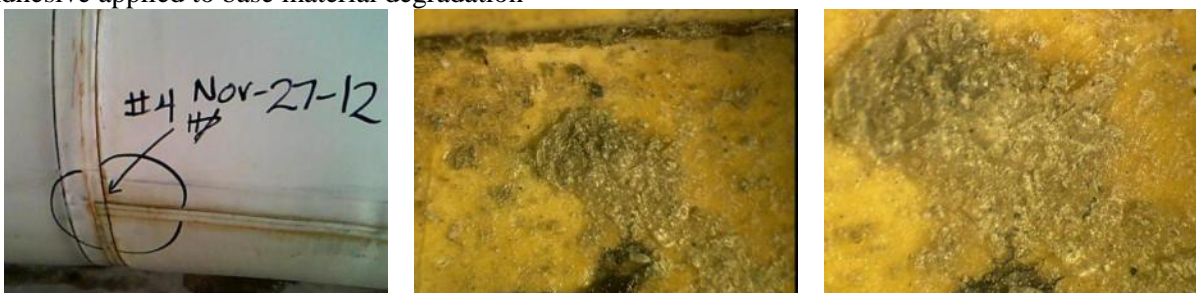
Figure 5.4.82 – Class II – T28-1 – Corner – 20 JUN 12
Air gun or extrudite gun miss causing scrim exposure, compound flow and gaps

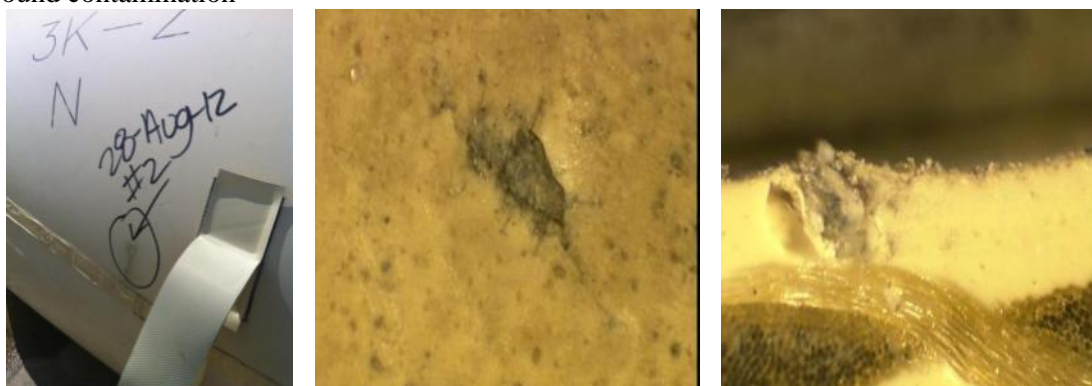
Figure 5.4.84 – Class I – T10-7 – Panel – 18 SEP 13
Hot air or extrudite gun miss forming crack in compound

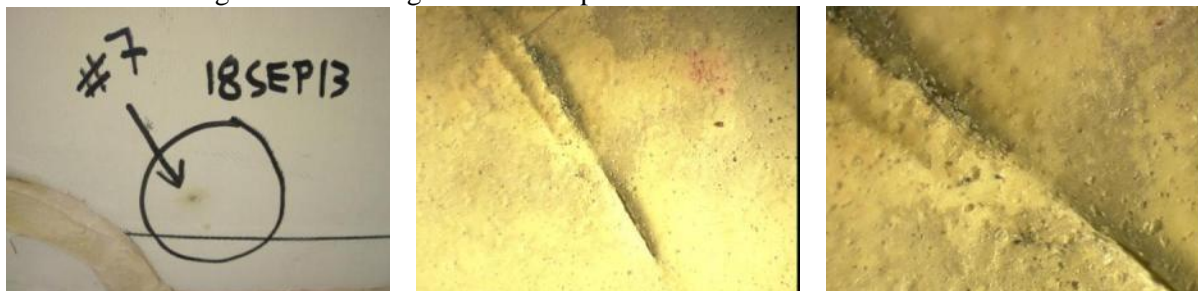
Figure 5.4.85 – Class I – T15-10 – Panel CL1 – 5 JUL 13
External surface contamination or chemical cleaning agent

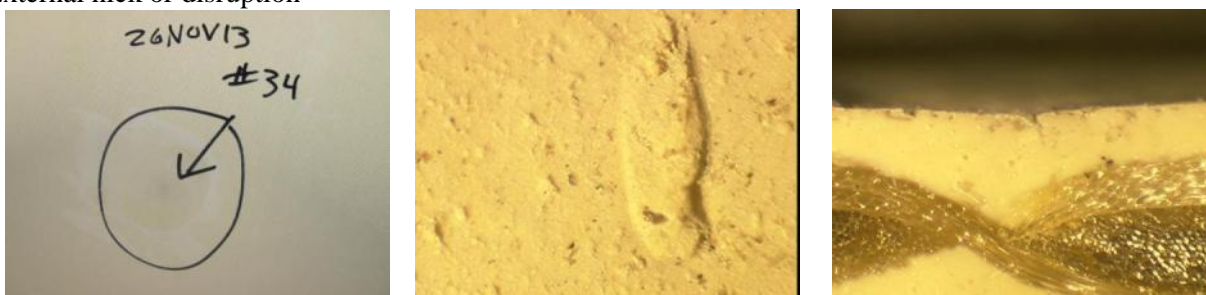
Figure 5.4.90 – Class I – T20-12 – T-Seam Closing – 23 SEP 13
Localized compound stiffening and stress cracking caused by cleaning agent, adhesive or both

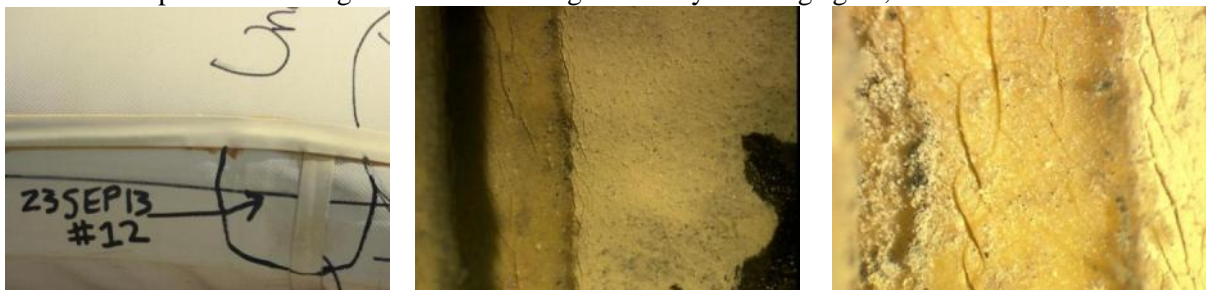
Figure 5.4.91 – Class I – T23-1 – T-Seam Closing CL1 – 23 SEP 13
Degradation of polymer due to cleaning agent or adhesive compound – closing procedure of seam

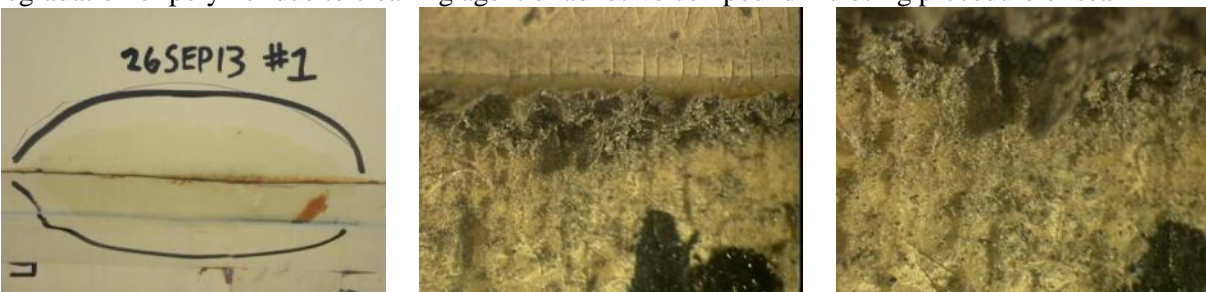
Figure 5.4.92 – Class I – T24-3 – Panel – 8 OCT 12
Internal coating contamination

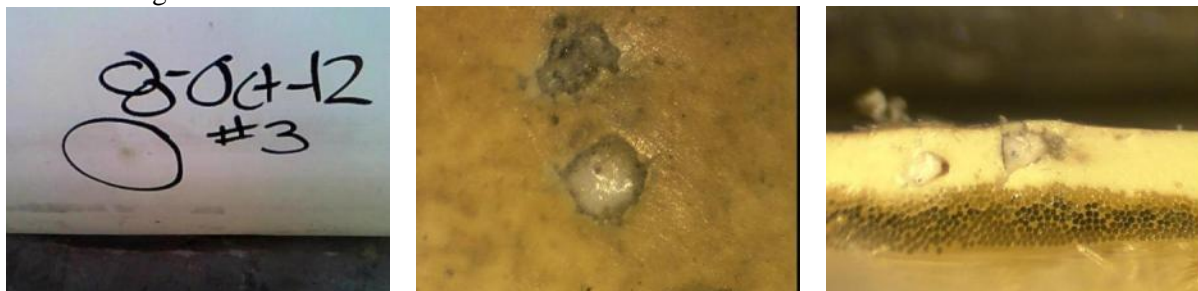
Figure 5.4.93 – Class I – T24-12 – Panel – 6 NOV 13
External contamination source which also caused adjacent material wrinkling

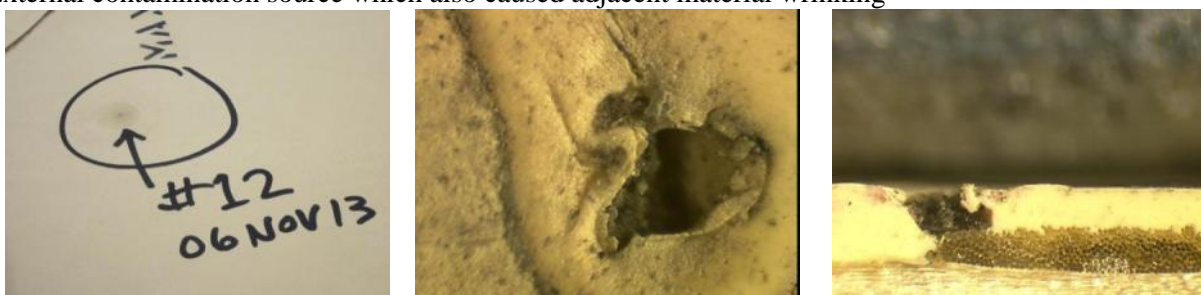
Figure 5.4.94 – Class I – T24-13 – Panel – 3 DEC 13
Internal contamination source due to up and out direction

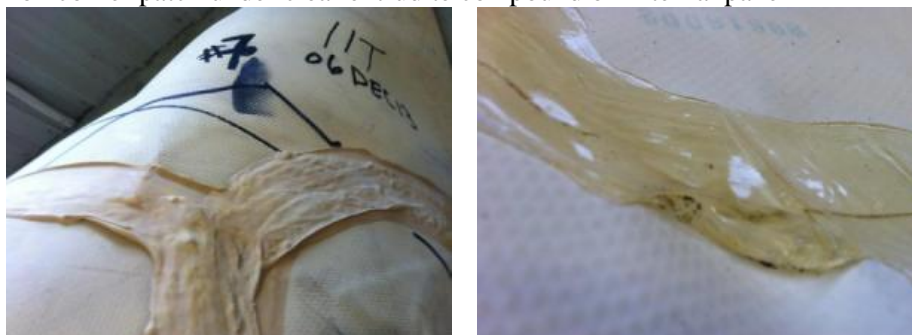
Figure 5.4.103 – Class I – T12S-5 – T-Seam Closing – 22 OCT 13
Outer Acute T-Seam leak location with inner tape and material wrinkling

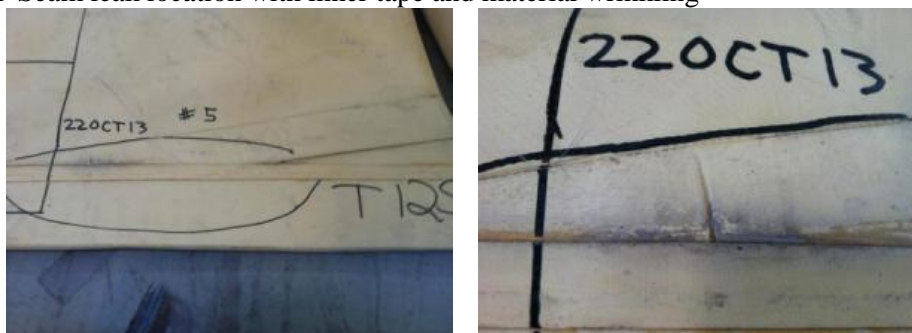
Figure 5.4.103 – Class I – T12S-5 – T-Seam Closing – 22 OCT 13 - continued
